HI-FLO SUCTION WITH VACUUM BREAK INSTALLATION INSTRUCTIONS

For Model Number: SPC-2 V with Vacuum Break System

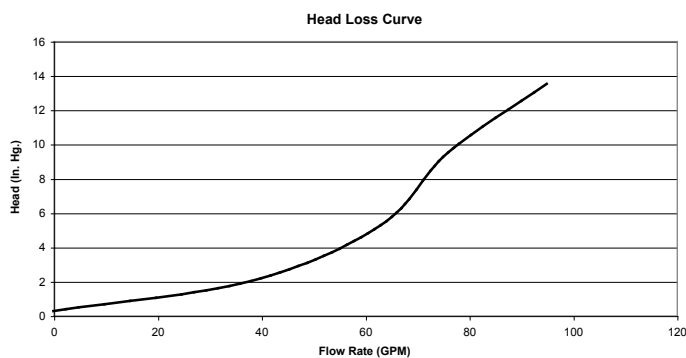
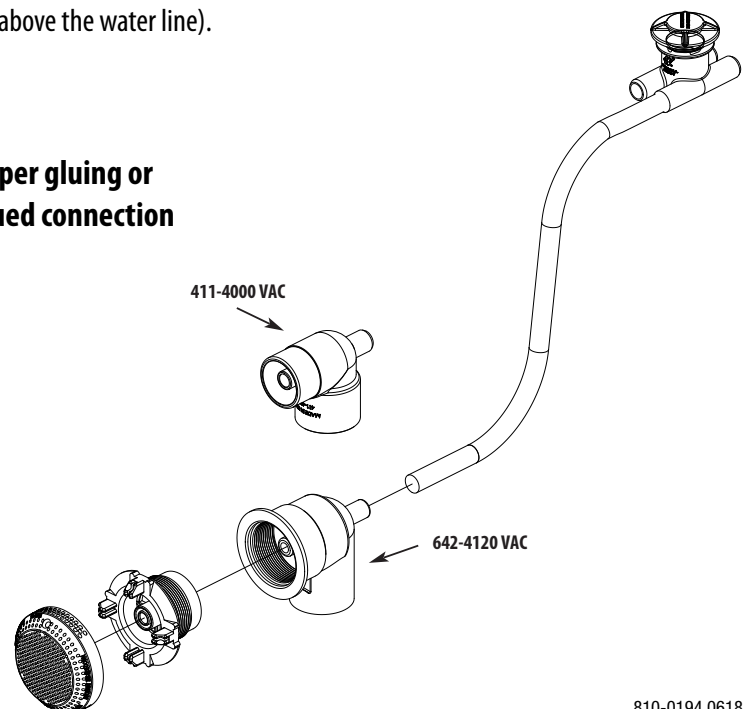
1. Locate and cut a 2 3/8" hole in a vertical wall of the spa. Be sure the area located is flat and spa laminate thickness is uniform.
2. Insert wallfitting with gasket through hole.
3. Apply a bead of silicon against the back wall of the spa and around the threads of the wall fitting . Avoid getting sealant on gasket.
4. Install nut and tighten. Be sure wallfitting screw studs are horizontal to bottom of spa.
5. Glue elbow supplied with fitting into wallfitting. Be sure to orient the elbow in the required direction while gluing.
6. Connect 3/4" vinyl tubing to the vacuum break barb on the elbow.
7. Raise up the other end of the 3/4" vinyl tubing to upper lip of the spa (above the water line).
8. The maximum length of the 3/4" vinyl tubing shall not exceed 14 feet.
9. Use 640-375x V suction vent as shown.
