HI-FLO SUCTION WITH VACUUM BREAK INSTALLATION INSTRUCTIONS

For Model Number: SPC-2 V with Vacuum Break System

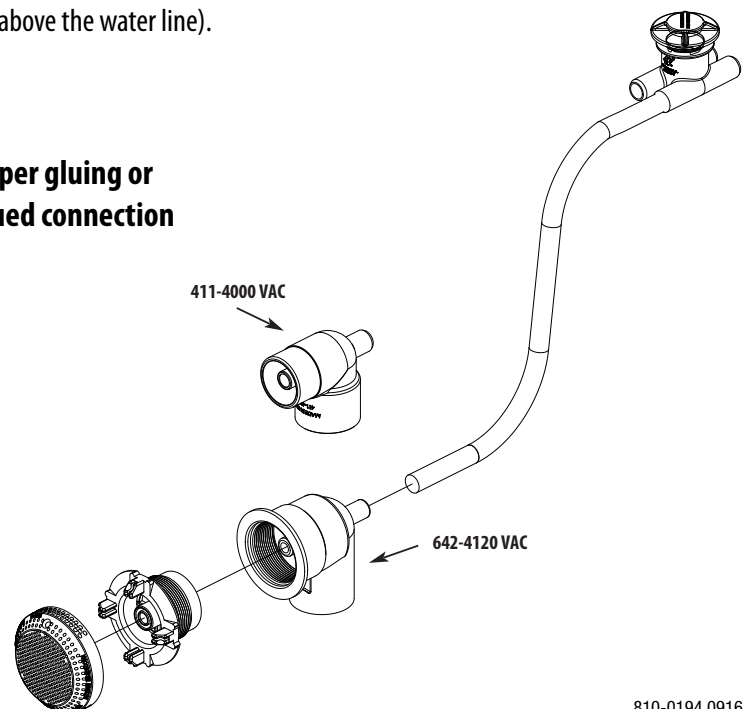
1. Locate and cut a 2 3/8" hole in a vertical wall of the spa. Be sure the area located is flat and spa laminate thickness is uniform.
2. Insert wallfitting with gasket through hole.
3. Apply a bead of silicon against the back wall of the spa and around the threads of the wall fitting . Avoid getting sealant on gasket.
4. Install nut and tighten. Be sure wallfitting screw studs are horizontal to bottom of spa.
5. Glue elbow supplied with fitting into wallfitting. Be sure to orient the elbow in the required direction while gluing.
6. Connect 3/4" vinyl tubing to the vacuum break barb on the elbow.
7. Raise up the other end of the 3/4" vinyl tubing to upper lip of the spa (above the water line).
8. The maximum length of the 3/4" vinyl tubing shall not exceed 14 feet.
9. Use 640-375x V suction vent as shown.

WARNING: This is a PVC to PVC connection. Improper gluing or improper cement selection can cause leaks at glued connection which can result in property damage.
