ULTRA HI-FLO SUCTION INSTALLATION INSTRUCTIONS

For Model Number: 640-349x V

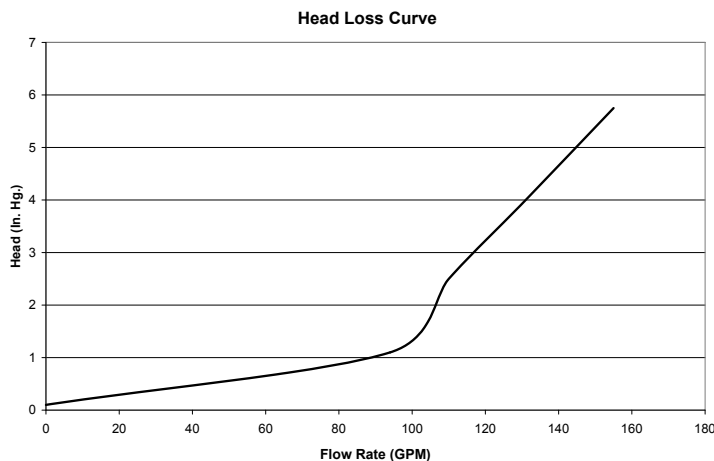
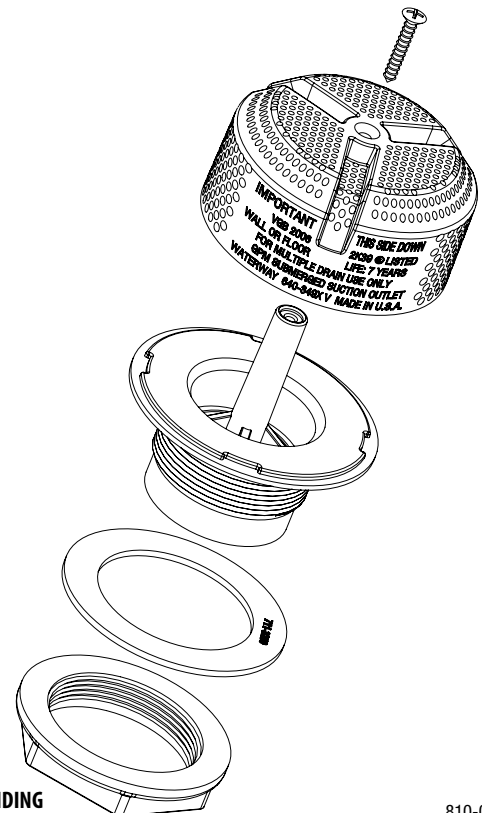
1. Locate and cut a 2 3/8" hole in a vertical wall of the spa. Be sure the area located is flat and spa laminate thickness is uniform.
2. Insert wall fitting with gasket through hole.
3. Apply a bead of silicon against the back wall of the spa and around the threads of the wall fitting. Avoid getting sealant on gasket.
4. Install nut and tighten. Be sure the side with no openings faces to the bottom of the spa. Please refer to the markings on the suction cover for proper orientation of the suction cover.
