ULTRA HI-FLO SUCTION INSTALLATION INSTRUCTIONS

For Model Number: 640-349x V

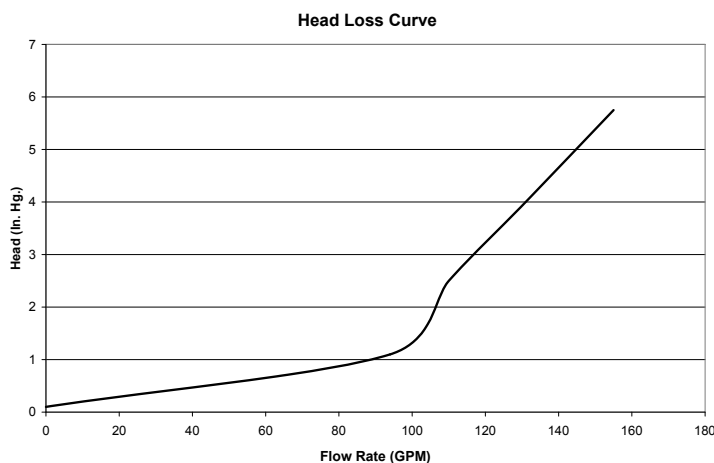
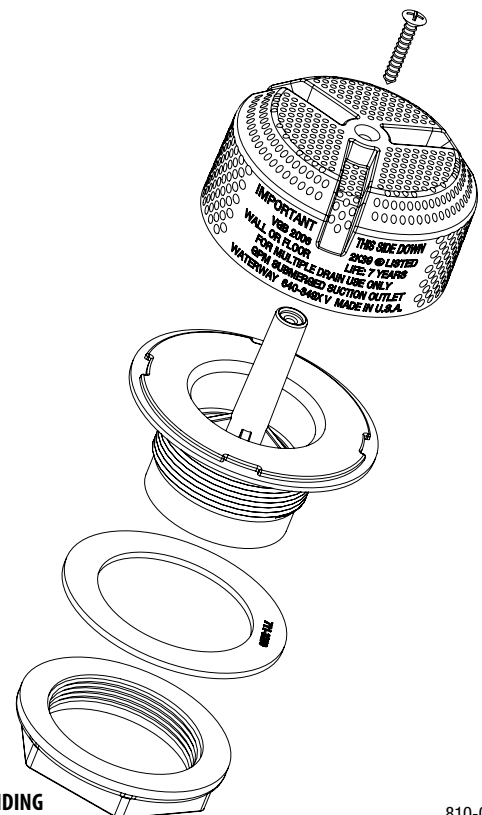
1. Locate and cut a 2 3/8" hole in a vertical wall of the spa. Be sure the area located is flat and spa laminate thickness is uniform.
2. Insert wallfitting with gasket through hole.
3. Apply a bead of silicon against the back wall of the spa and around the threads of the wall fitting . Avoid getting sealant on gasket.
4. Install nut and tighten. Be sure the side with no openings faces to the bottom of the spa. Please refer to the markings on the suction cover for proper orientation of the suction cover.
