HI-FLO SUCTION FOR SELF-CONTAINED SPAS INSTALLATION INSTRUCTIONS

For Model Number: SPC-2 VP

**VGBA
2017**

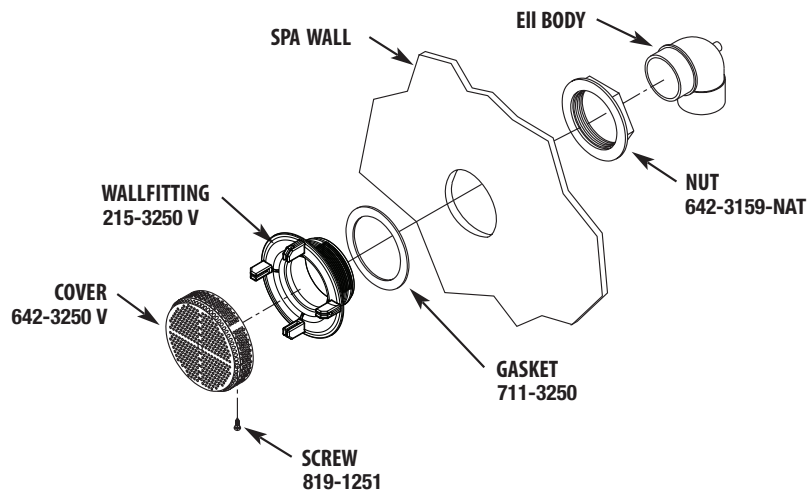
1. Locate and cut a 3 1/4" hole in a vertical wall of the spa. Be sure the area located is flat and spa laminate thickness is uniform.
2. Insert wallfitting with gasket through hole.
3. Apply a bead of silicone against the back wall of the spa and around the threads of the wall fitting . Avoid getting sealant on gasket.
4. Install nut and tighten. Be sure wallfitting screw studs are horizontal to bottom of spa.
5. Glue elbow supplied with fitting into wallfitting. Be sure to orient the elbow in the required direction while gluing.

FLOW PATH ZONE DIMENSIONS:

This is a sumpless drain.
