5" ULTRA FLO SUCTION FOR SELF-CONTAINED SPAS INSTALLATION INSTRUCTIONS

For Model Number: 640-393x V

VGBA 2017

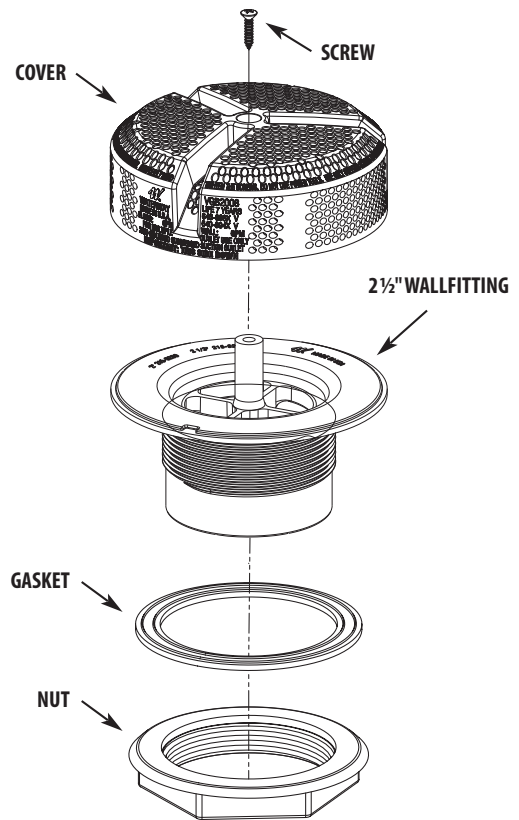
1. Locate and cut a 3 ¼" hole in a vertical wall of the spa. Be sure the area located is flat and spa laminate thickness is uniform.
2. Insert wallfitting with gasket through hole.
3. Apply a bead of silicon against the back wall of the spa and around the threads of the wall fitting . Avoid getting sealant on gasket.
4. Install nut and tighten. Be sure wallfitting screw studs are horizontal to bottom of spa.
5. Glue elbow supplied with fitting into wallfitting. Be sure to orient the elbow in the required direction while gluing.

NOTE: The size of the plumbing shall not be reduced for at least 16" after the point of connection to shown wallfittings.

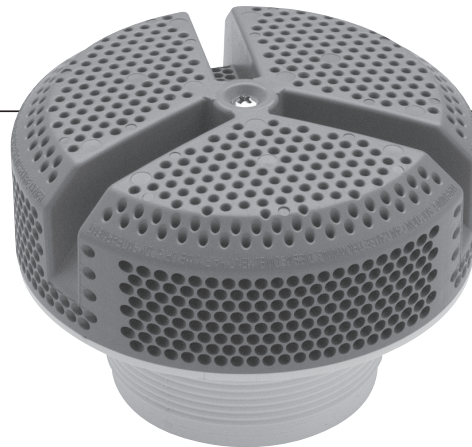
Wall Flow Rate: **264 GPM with 2" wall fitting**
215-3280 and 2 1/2" wall fitting 215-3290

Wall Flow Rate: **224 GPM for 640-393x V**

The 640-393x V fitting is rated at 224 GPM with wall fitting 215-3290. If the fitting is missing or broken, replace with a fitting of equivalent rating or higher. Use of a lower rated suction fitting could result in entrapment of the body which could result in serious injury including drowning.
