# GRATE AND FRAME OWNER'S MANUAL

Model Number: 640-477X V 18" x 18" Grate & Frame

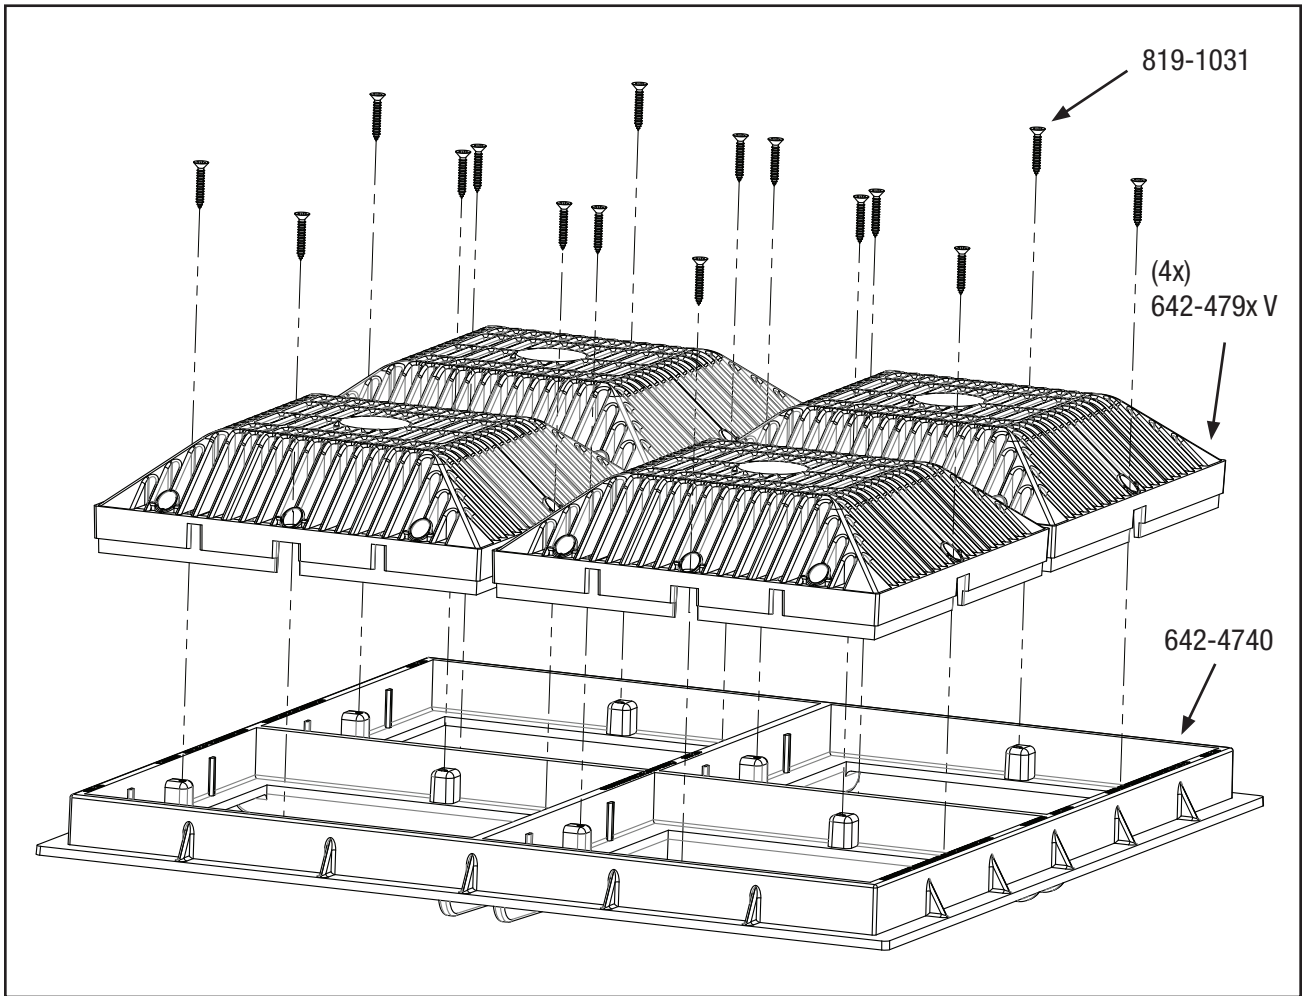
**Required Tools:** Philips screw driver bit and torque wrench. Hand tighten screws. DO NOT use power tools. Torque fasteners to a maximum of 20 in-lb.

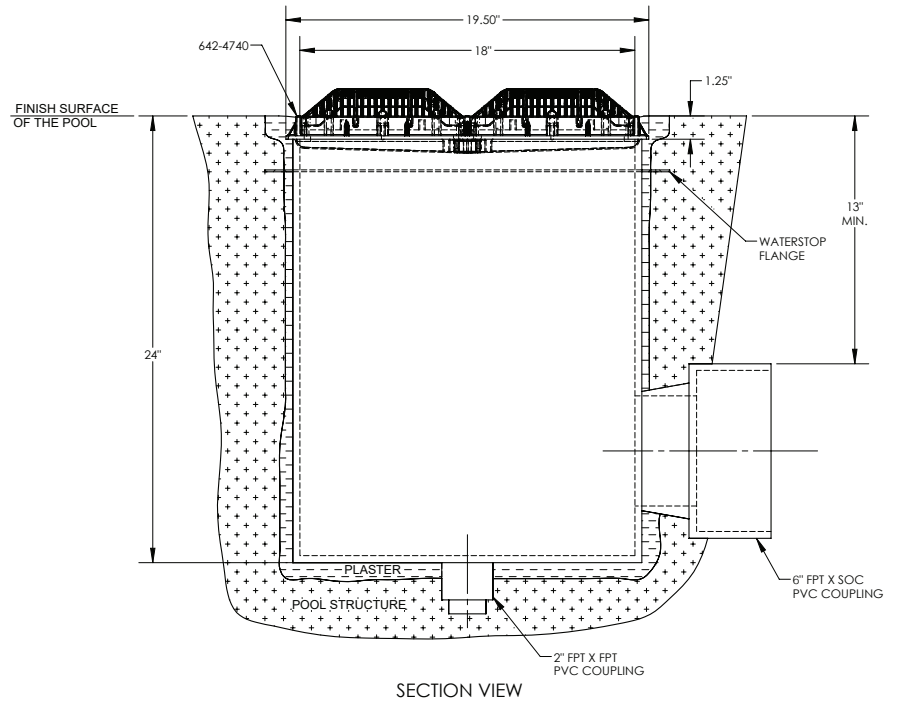
### FIELD FABRICATED SUMP

- PVC Pipe Size: 6"
- Min Sump Depth: 13"
- Min Ledge Depth: 1.75"
- Max Ledge Width: 19.5"
- Min Pipe Offset: N/A
- Min Length Before Reduction: 3"
