GRATE AND FRAME OWNER'S MANUAL

Model Number: 640-479XV 9" x 9" Grate and Frame

VGBA 2017

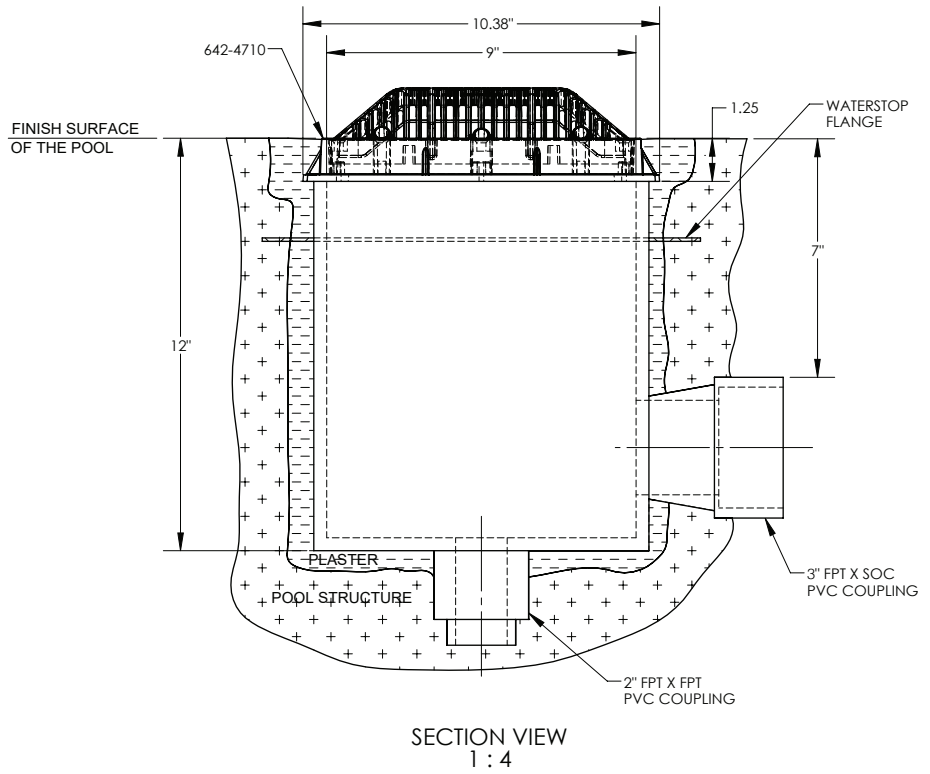
FIELD FABRICATED SUMP

- PVC Pipe Size: 3"
- Min Sump Depth: 7"
- Min Ledge Depth: 1.25"
- Max Ledge Width: 10.38"
- Min Pipe Offset: N/A
- Min Length Before Reduction: 9"

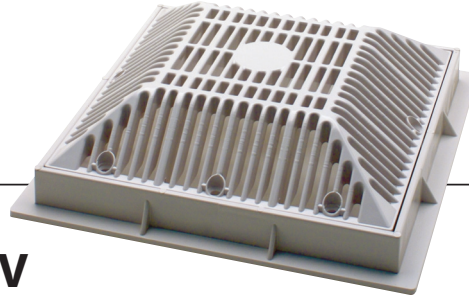
9" x 9" GRATE & FRAME

Part Number: **640-479X V**

Description: **Grate & Frame**

Size: **9" x 9"**

Open Area: **43.6 in²**

GPM @ 1.5 fps: **203**

Floor Flow Rate: **240 GPM**

Wall Flow Rate: **208 GPM**
