GRATE AND FRAME OWNER'S MANUAL

Model Number: 640-479X V 9" x 9" Grate and Frame

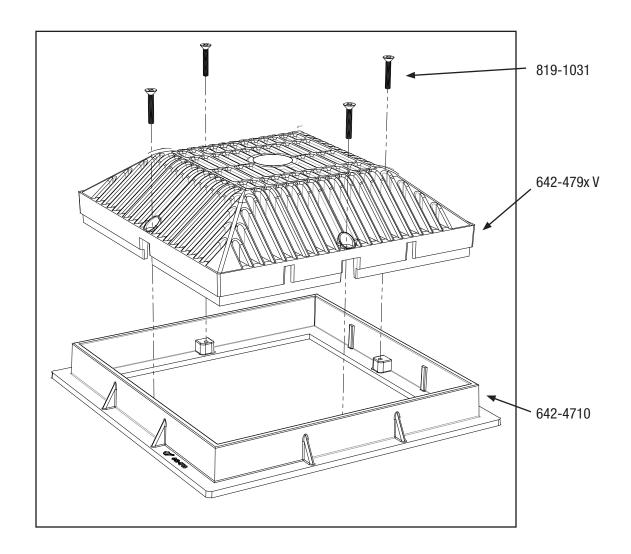
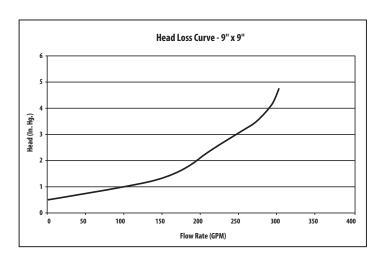
Required Tools: Philips screw driver bit and torque wrench. Hand tighten screws. DO NOT use power tools. Torque fasteners to a maximum of 20 in-lb.

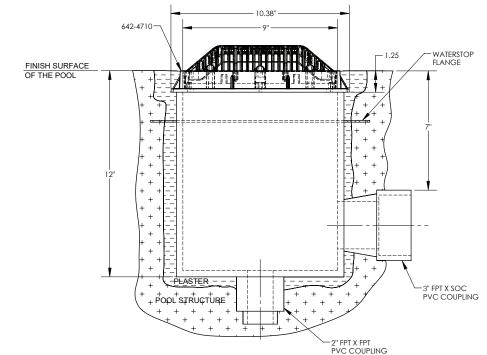
FIELD FABRICATED SUMP

SECTION VIEW 1:4

Min Length Before Reduction: 9"

PVC Pipe Size: 3"
Min Sump Depth: 7"
Min Ledge Depth: 1.25"
Max Ledge Width: 10.38"
Min Pipe Offset: N/A
